Jones Ball Fields Site
Northwest Corner of Britton Road/Main Street and Henney Road
Jones, Oklahoma, Oklahoma County

Summary of DEQ Activities

August 19, 2015

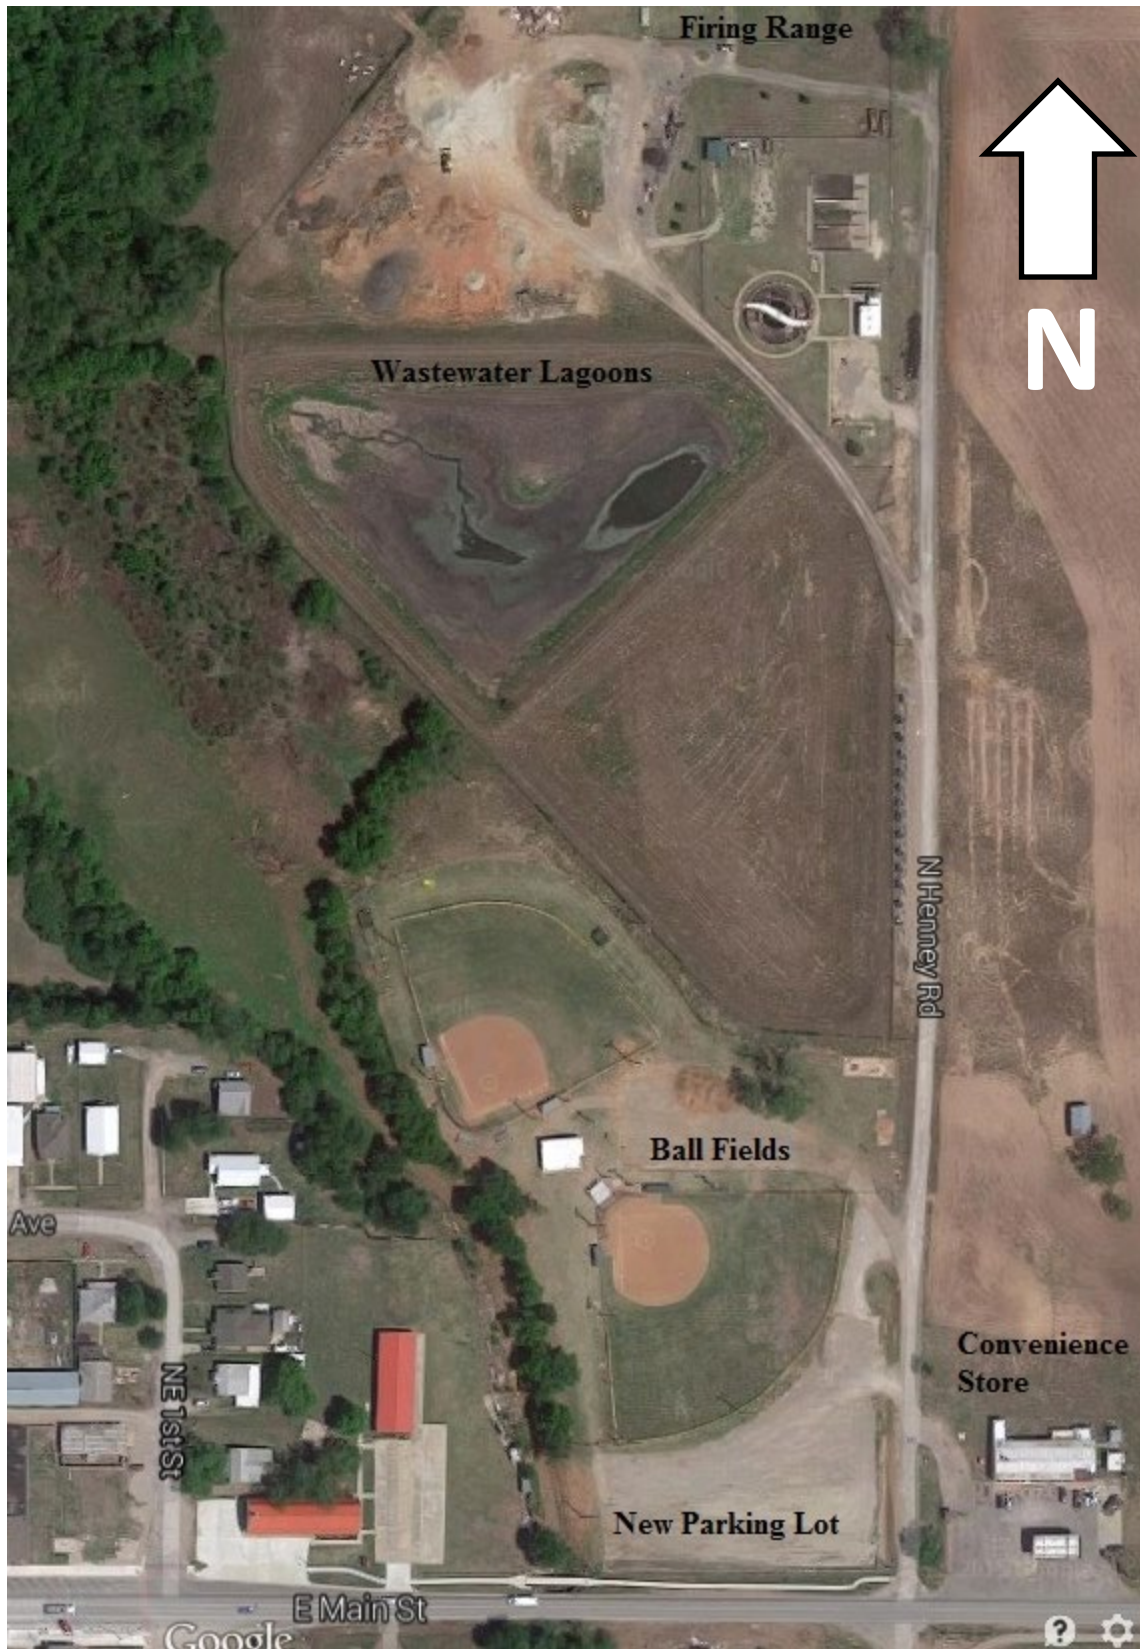
Figure 1: Site Vicinity – Jones, OK

The Jones Ball Fields Site is a former battery casing dump located at the northwest corner of Britton Road/Main Street and Henney Road in Jones, Oklahoma. The Jones Ball Fields are currently owned by the Town of Jones. Wastewater lagoons and a firing range owned by the Town of Jones are located to the north of the ball fields. A small creek forms the western edge of the ball fields and a convenience store is located to the east of the ball fields (see Figure 1).

The Jones Ball Fields are located in the Town of Jones, Oklahoma, in Oklahoma County (see Figure 1). The site is near a small tributary of the North Canadian River and a portion of the North Canadian River historically flowed through the northeast corner of the site. This area of Oklahoma County typically has short, mild winters and long, hot summers. Temperatures throughout the year can vary from below 0°F to above 100°F. Average annual precipitation is about 32 inches with most of it occurring in the spring. Soil along the North Canadian River and other large streams is best characterized by deep, nearly level, loamy sandy soils and is part of the Canadian-Dale soil complex. Soils in this complex are easy to till, have good water-holding capacity, and have medium to high fertility (Fisher, 1969). The thickness of the terrace deposits typically range from 50 to 100 feet in depth. Terrace deposits along the North Canadian River can be major aquifers. Groundwater wells in Jones, Oklahoma typically yield water that is good to fair chemical quality with some hardness and dissolved solids. These wells usually produce at a rate of 75 gallons per minute (Bingham, 1983). The topographic gradient near the site appears to be to the southwest towards Jones Creek with some storm water runoff flowing to the south and east towards the pond that is southeast of the Ball Fields.

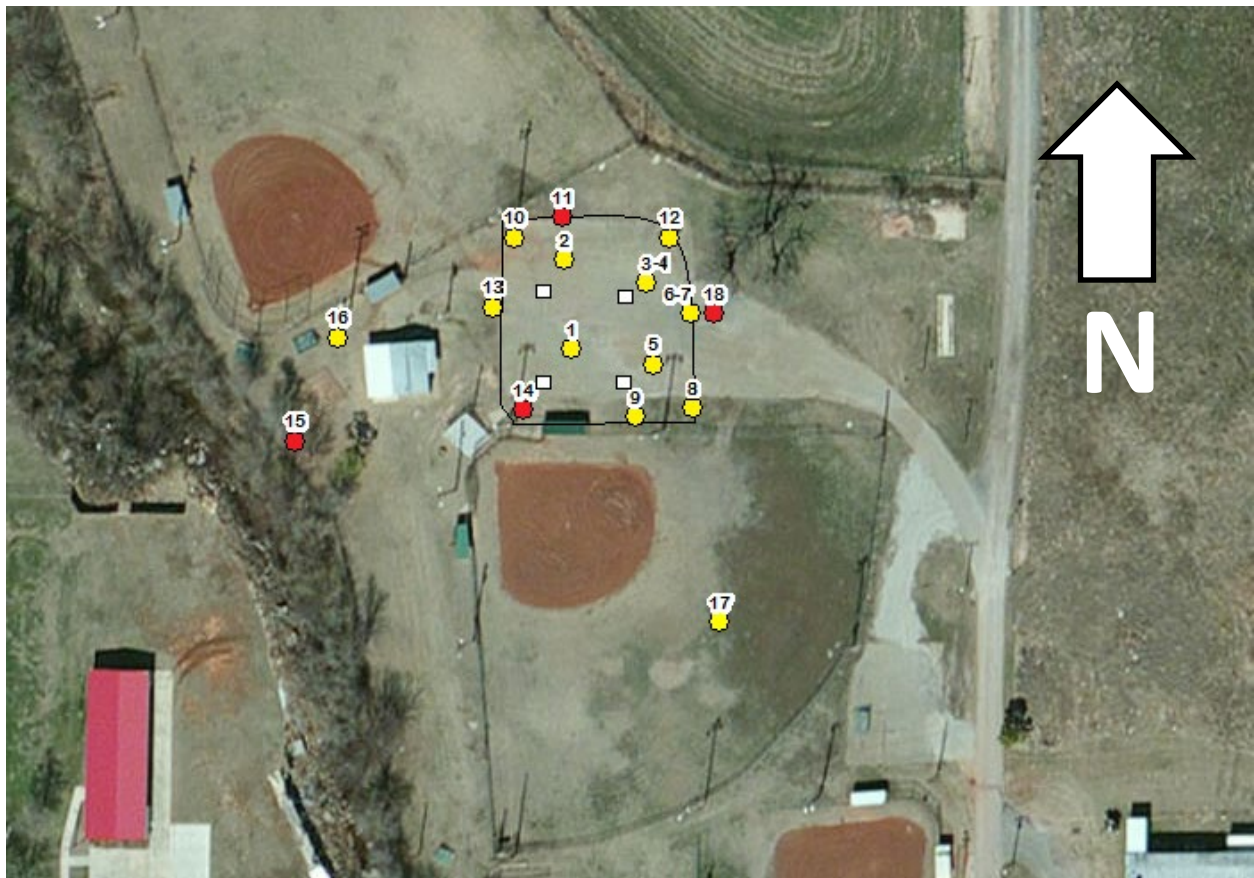
Figure 3: Soil Sample Locations

On April 3, 2015, DEQ personnel took soil samples at the Jones Ball Fields (see Figure 3). Composite samples and grab samples were taken from the 0-6 inch soil interval. All samples were analyzed for lead. Refer to Table 1 for sample ID, location of sample, sample collection method, and lead value. Areas highlighted in gray exceed levels determined to be acceptable for the site (>500 ppm lead). Four samples (sample numbers 11, 14, 15, and 18) exceeded acceptable lead levels and had lead concentrations that ranged from 597 to 2270 ppm lead (Figure 4).

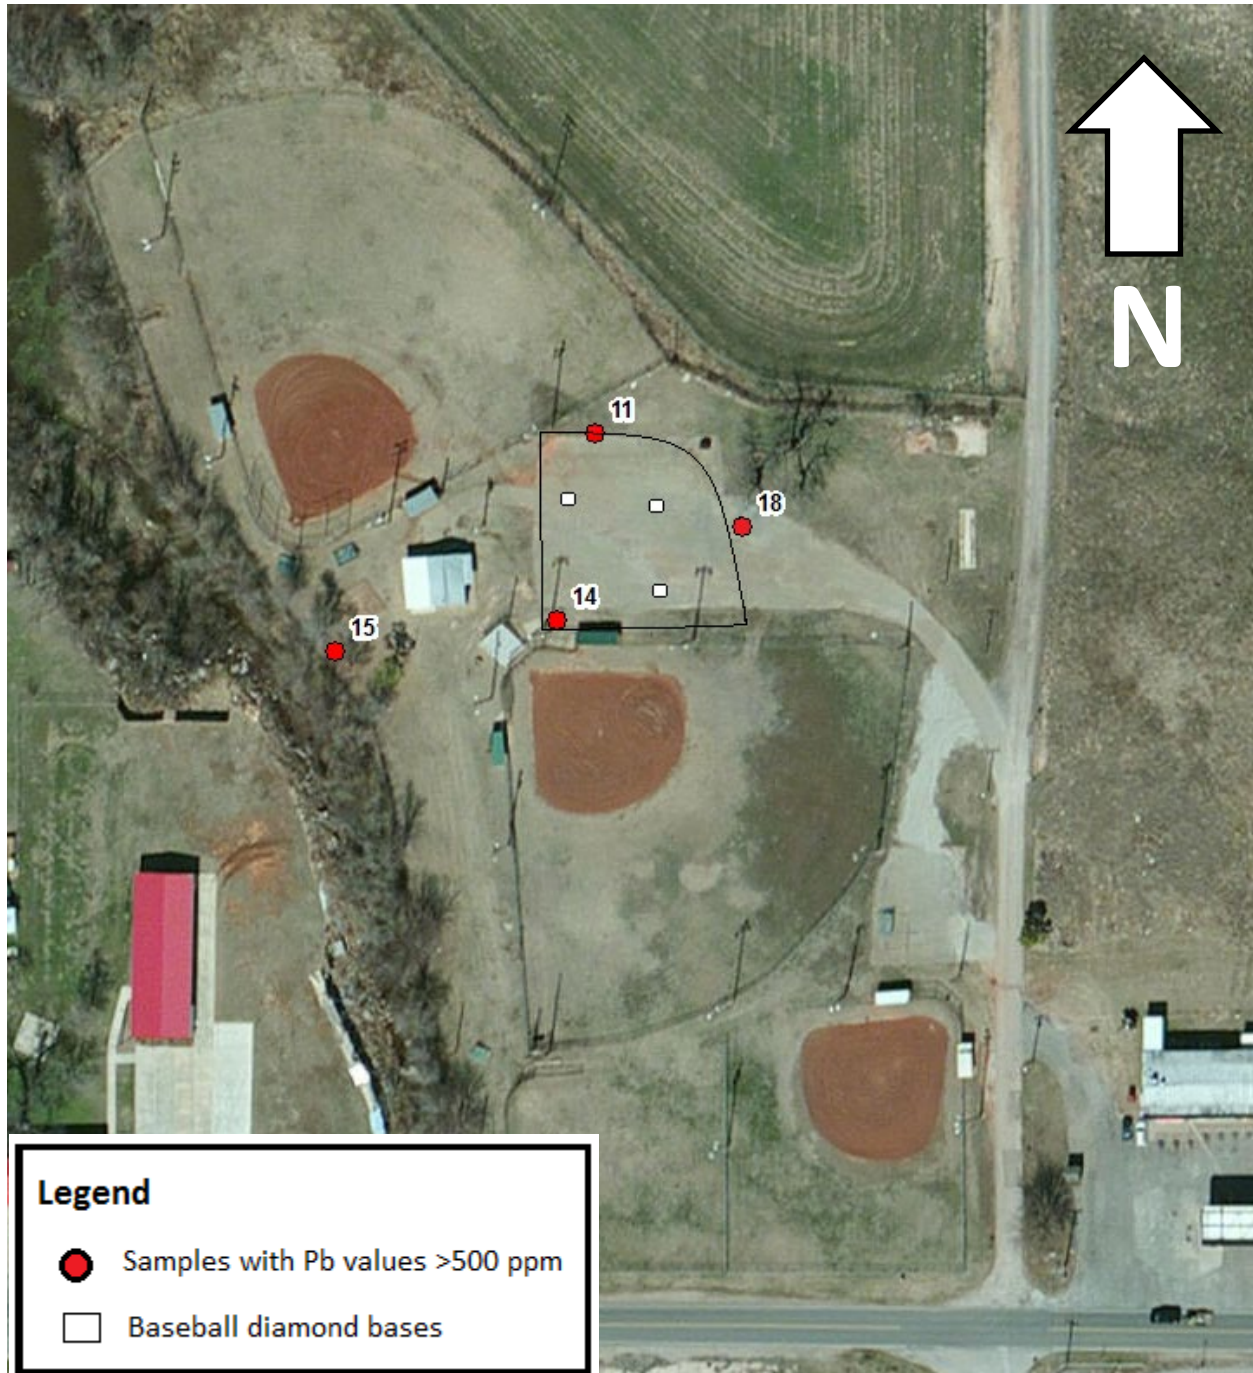
Figure 4: Soil Sample Locations for values greater than 500 ppm Pb

The sample results demonstrated that areas associated with recent excavation (i.e. fence work, water line installation, electrical work) contained the highest lead concentrations. Due to recent excavation for the installation of fence posts and new ball field lighting, the dirt around the new fence posts and the debris pile on the western side of the site were the most highly contaminated. Additionally, the gravel from the parking area east of the T-ball field where digging had occurred to install a water line was also contaminated.

DEQ recommends that any excavated soil produced from future construction activities be removed, properly disposed of, and replaced with clean soil prior to use of the T-ball field. The T-ball field should be inspected and maintained regularly. Additionally, erosion prevention measures such as pavement, grass, or gravel should be placed on top of areas where soil has eroded. Sod should be replaced where it has worn down. DEQ also recommends that the gravel area east of the T-ball field be capped with clean soil and grass, gravel, pavement, or equivalent prior to the creation of a playground in that area.
